RISK AND VULNERABILITY OF CONTEMPORARY ART: A NEW CHALLENGE?

The vulnerability of three domes of the Faculty of Visual Arts, designed by Ricardo Porro Hidalgo between 1961-1965 in La Habana (Cuba), has been the subject of our study. A model of vulnerability and risk based on the state of conservation and its relationship with static and structural factors, climatic conditions, air quality, level of usage, cataloguing and constructive simplicity has been employed. The vulnerability indexes were calculated based on a Leopold matrix that depends on intrinsic variables and the life of the monuments. The result reproduces human reasoning to study relations between vulnerability, risk factors and state of conservation of contemporary monuments. New designs and contemporary materials such as those that were used by Ricardo Porro Hidalgo in this monument imply modifications in the study of vulnerability indexes.

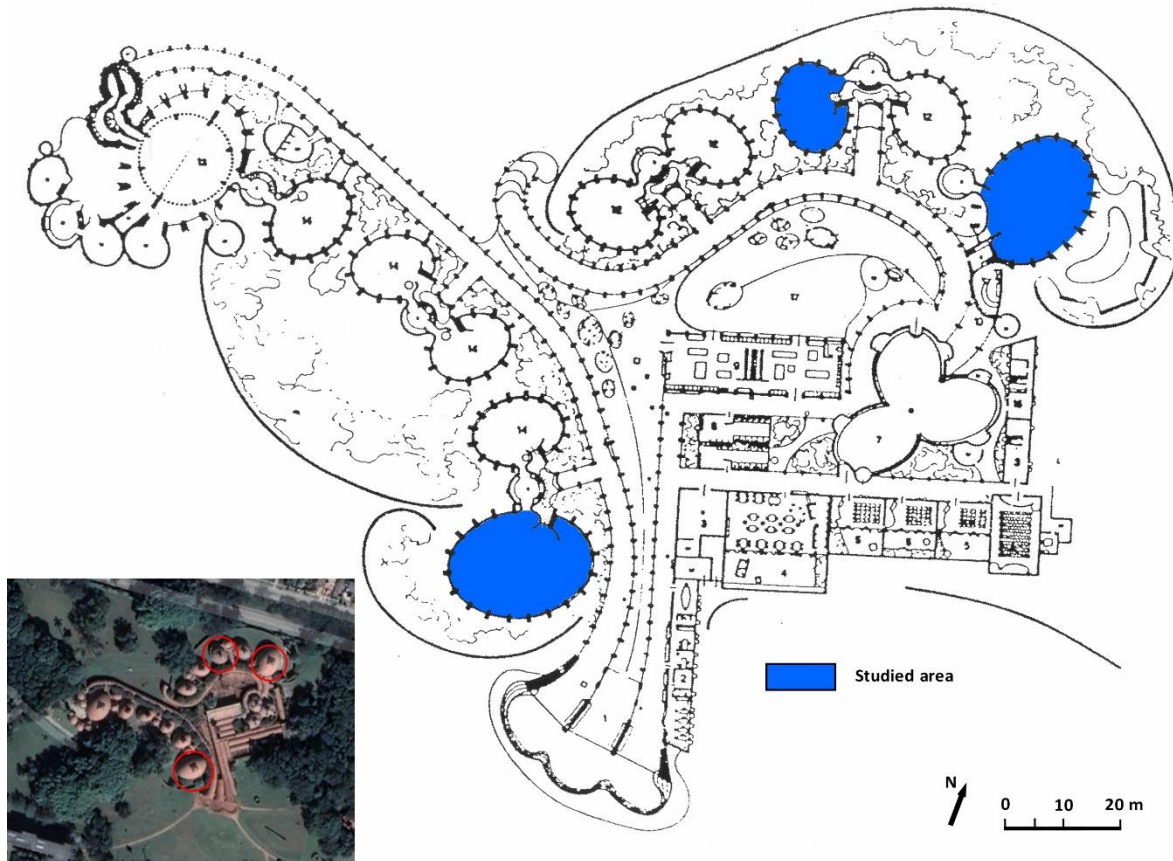
**Figure 2.** Map of Faculty of Plastic Arts by Ricardo Porro Hidalgo with the location of the three domes in blue.

Three domes are chosen for the study of vulnerability in order to develop a methodology that could be employed in the rest of the monument. *Table 1* summarizes the code and current use for each dome while figure 2 is a map of the building with the location of the three domes.

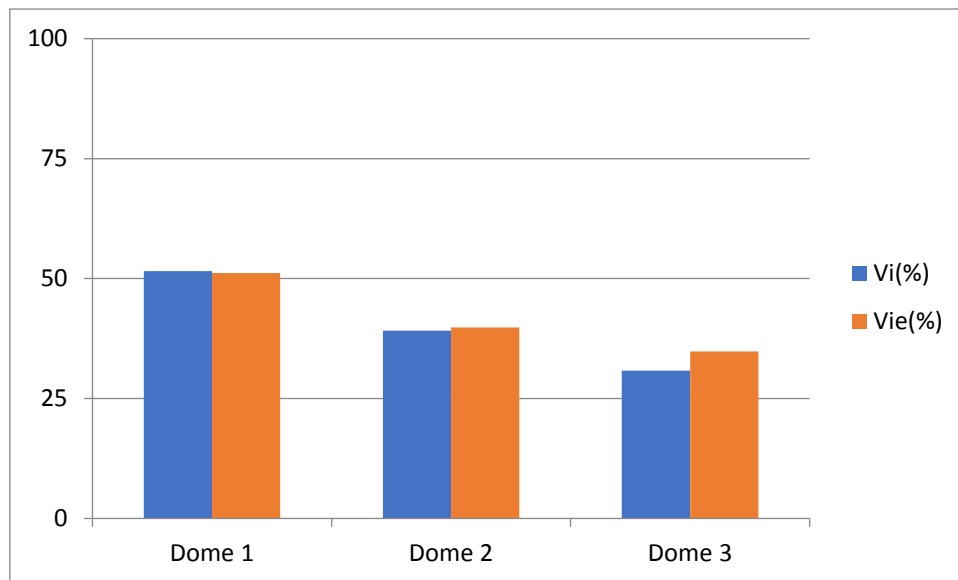
Figure 4. Vulnerability Index and Expanded vulnerability index of the three domes.

Results of vulnerability index and expanded vulnerability index are shown in figure 4. Currently, the dome 1 is the most vulnerable with a vulnerability index V_i average of 51%, that implies a high vulnerability according to the classification of Galán et al. [28], while the other two domes have a moderate vulnerability, 40% and 35%, respectively for Dome 2 and 3. These results imply that the state of conservation of Dome 1 makes it more vulnerable to extrinsic factors than the other monuments.

Moreover, for these domes with moderate and high vulnerability, a yearly monitoring and inspections is recommended to update the analysis.

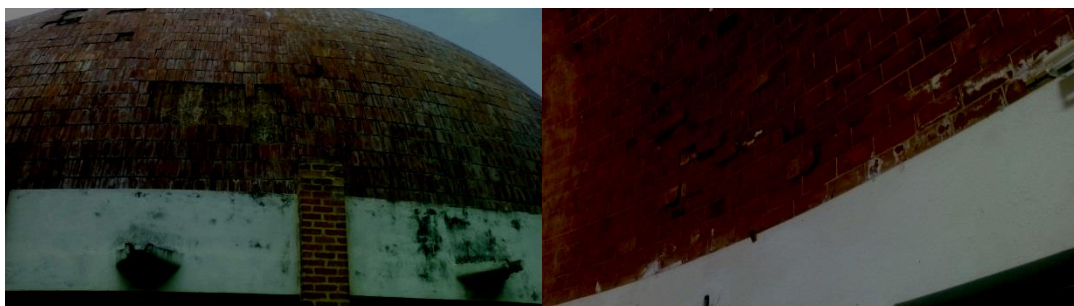
Figure 5. Conservation state of Dome 1 with coloration or discoloration, missing part, moist areas, scaling and efflorescence.

In this study, the monument has different levels of conservation that range from moderate to highly vulnerable. The most vulnerable dome studied is Dome 1, which is highly vulnerable due to appreciable detachment of the roof, abundant missing parts and chromatic alteration due to the alteration of bricks, or efflorescence, black crusts, vegetation, and signs of previous intervention with apparently incompatible bricks, while the other two domes show moderate vulnerability.
